Session: HDPE Pipe Test

Pilot Project with HDPE Provides Critical Alternative

Rafael Ortega, PE Lockwood, Andrews, & Newnam, Inc., Houston, Texas
Greg Henry, PE Lockwood, Andrews, & Newnam, Inc., Houston, Texas
Roel Huerta, EIT Lockwood, Andrews, & Newnam, Inc., Houston, Texas
Jonathan Prevot, EIT City of Houston, Texas

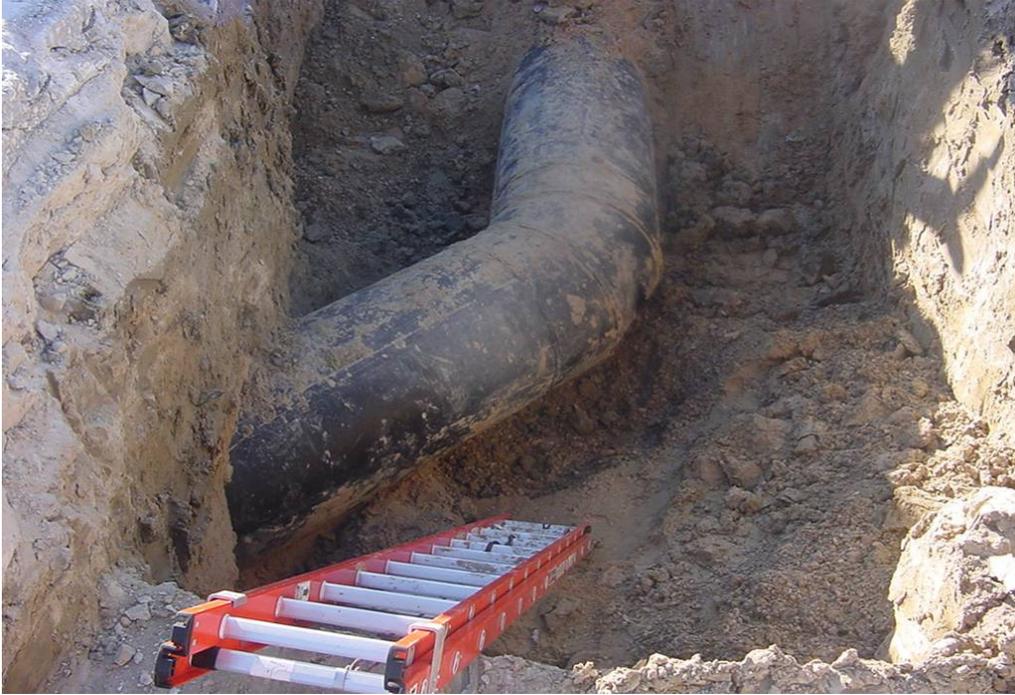
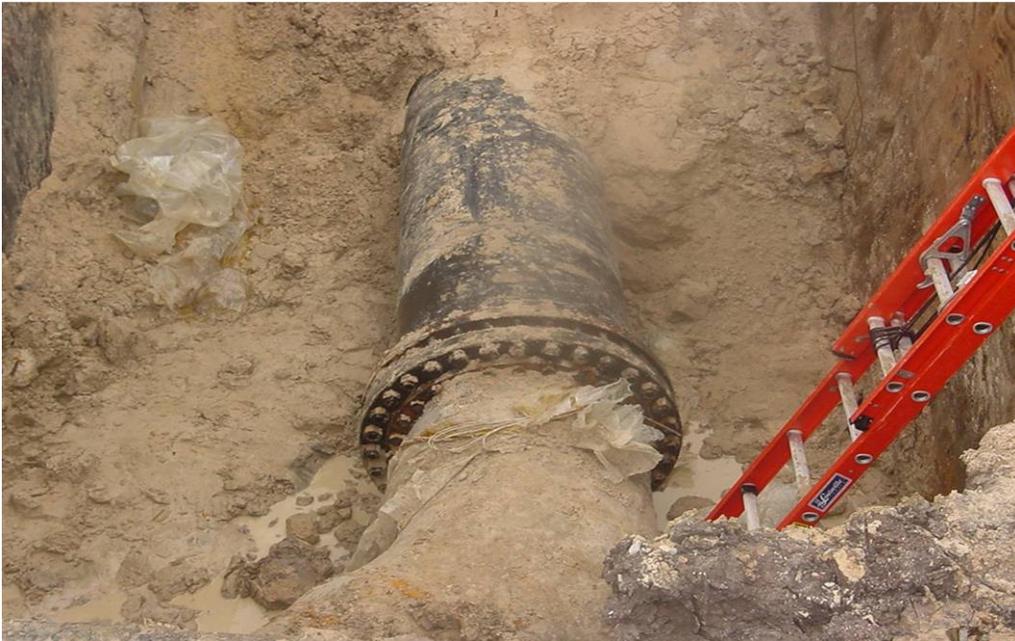
No leaks were observed in the butt-fused joints or at the flanged connection. Also, the OD of the HDPE water main was measured at each of the exposed locations to determine if ballooning or elongation of the HDPE line had occurred as a result of thrust. The OD of the pipe matched the original OD prior to installation. However, if these phenomena occur simultaneously, they may have offsetting effects that are difficult to quantify individually.

Based on the results of the limited assessment, the HDPE water main at each of the referenced locations is performing adequately under the current operating conditions.

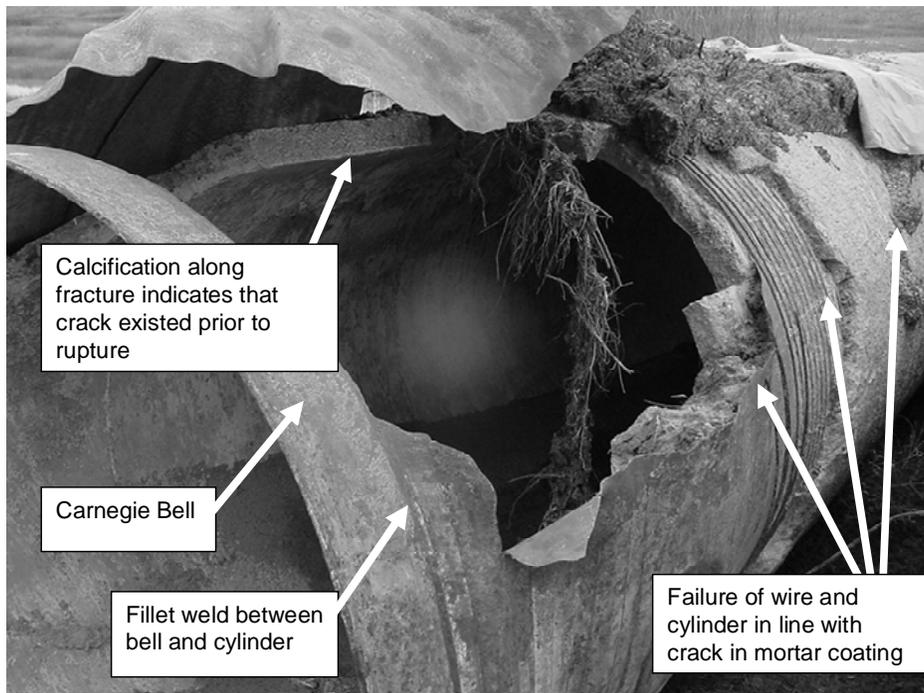
Figure 2. Failed pipe section

During the early morning hours of June 8, 2004, an existing 42-inch water main in Houston suffered a catastrophic failure. This failure occurred in a pipe section of PCCP installed in 1991 through 1992. The area served by the pump station consists of an area of approximately 75 square miles. Several residential properties were flooded as a result of the failure. The City authorized Lockwood, Andrews & Newnam, Inc. (LAN), to assist in the failure assessment and to design the repair for the water line.

Immediately following the rupture, LAN performed a visual inspection of the failed water line and testing of mortar and wire samples. Internal observations revealed the internal cracking appeared consistently at invert, crown, and spring lines for a distance of approximately 25,000 linear feet (see Figures 2, 3 and 4). The visual inspection was accompanied by sounding to determine if the mortar lining was delaminating from the steel cylinder; however, the lining did not exhibit any noticeable delaminations.

It was determined the repeated rapid closure of an emergency shut-off valve within the plant probably created pressure transients which could have exceeded the pipe design and caused the cracking. Hydraulic modeling of this closure scenario performed after the failure indicated that pressures in the pipe may have surged above the maximum design of the pipe of 150 psi for a total surge pressure of approximately 300 psi.

Several options, including replacing the line, were evaluated for restoring surface water to the pump station. Sliplining the existing water line with HDPE meant the existing water line could be used as a primary liner, reducing disruption to pavement and traffic. The disadvantages included requirements that flow into the pump station be shut down during the duration of construction, and the capacity of the line would be reduced to approximately two-thirds of its original capacity.

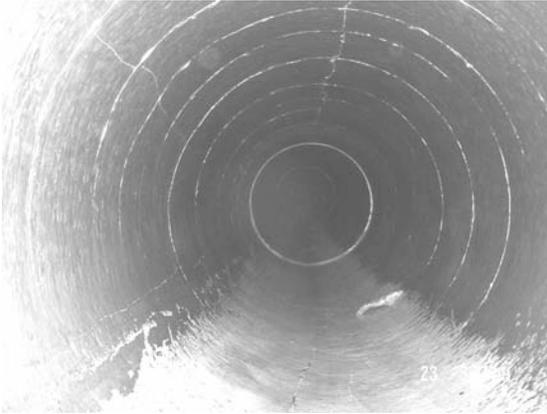
Circumferential cracks

Figures 2 and 3. Interior cracking

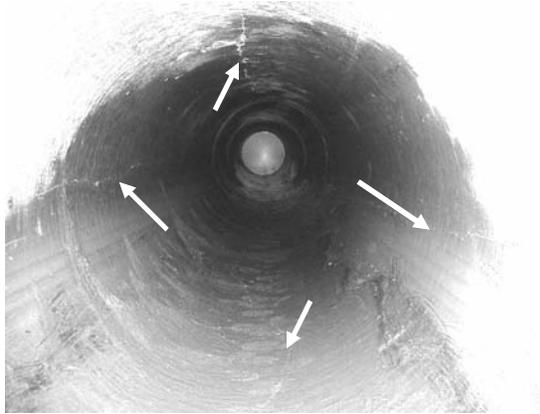
Cracks appeared constantly along crown, invert, and springlines

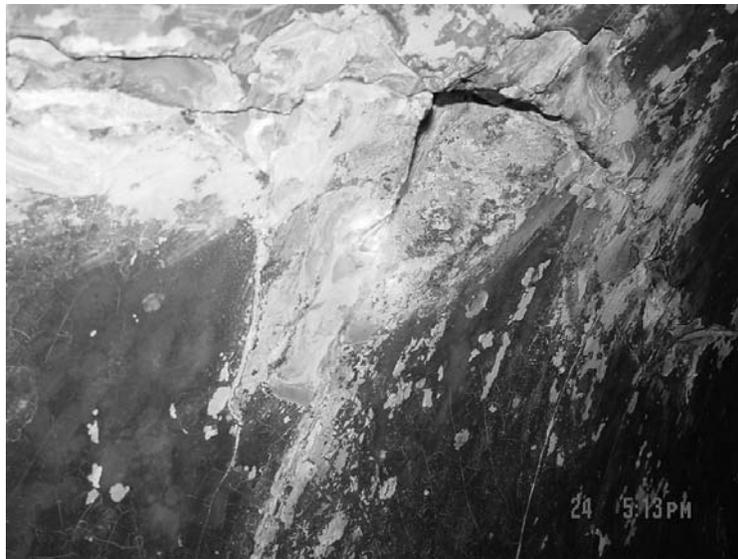
Figure 4. Close-up of interior mortar crack

Several pipe sections were excavated to investigate how the internal cracking correlated to overall pipe condition. Each piece excavated showed signs of external cracking, approximately in line with the internal cracks, indicating the cracks extended through the entire pipe wall. Limited wire testing performed on sample revealed no signs of hydrogen embrittlement or other obvious manufacturing defects.

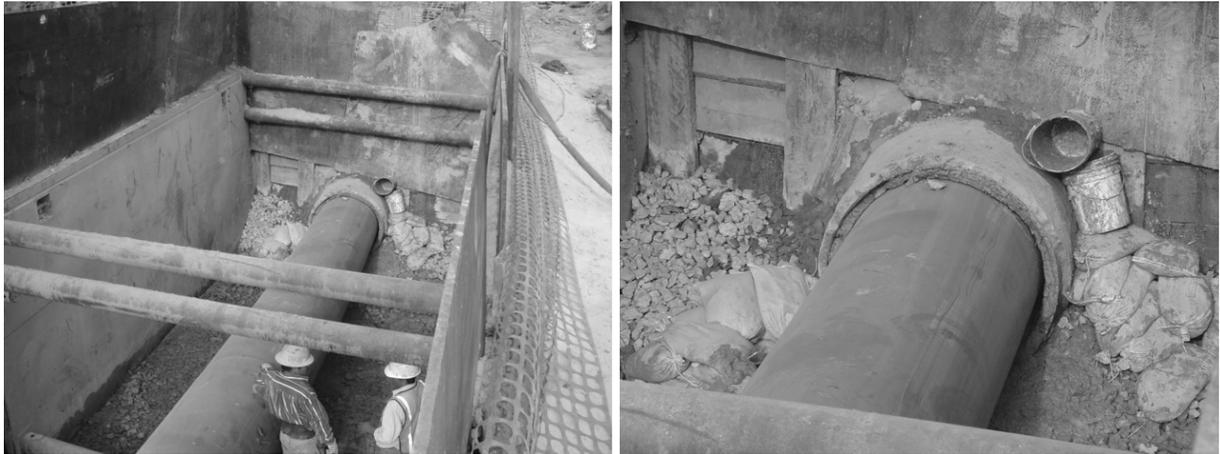
Figure 6 and 7. Pipe installation

Photographs included as Figures 6 and 7 show the tight fit of the slipline pipe.

The 40-foot-long test section of HDPE which served as a mandrel was a good indicator of the ease of pipe insertion. One additional access pit was required along the project, and was determined when the test mandrel got stuck. The actual HDPE water main never became stuck during pulling. During installation, the contractor was able to overcome friction between the host pipe and the slipline pipe by applying a viscous bentonite material along the invert of the existing pipe prior to insertion.
