PLASTIC PIPES IN WATER DISTRIBUTION SYSTEMS. A STUDY OF FAILURE FREQUENCIES.

I Bjorklund*

Investigations of failure frequencies in municipal water distribution networks have been performed on several occasions over the past 15 years in Sweden. In a follow-up study, reasons for failure in PVC and PE water pipes during the period 1986-1990 have been studied. It was found that PVC pipes manufactured after -73 have significantly improved failure frequencies compared with pipes manufactured before this date. Pipe failures are rare for PE pipes in general and for PVC pipes manufactured after 1973. Joint failures are 2-4 times more frequent than failures in the pipe itself. The study indicates that for modern PVC and PE pipes, it is probably possible to achieve a failure frequency of around or below 0,1 failures/10 km,year which is roughly 10 times less than the average failure rate recorded for the current Swedish distribution network.

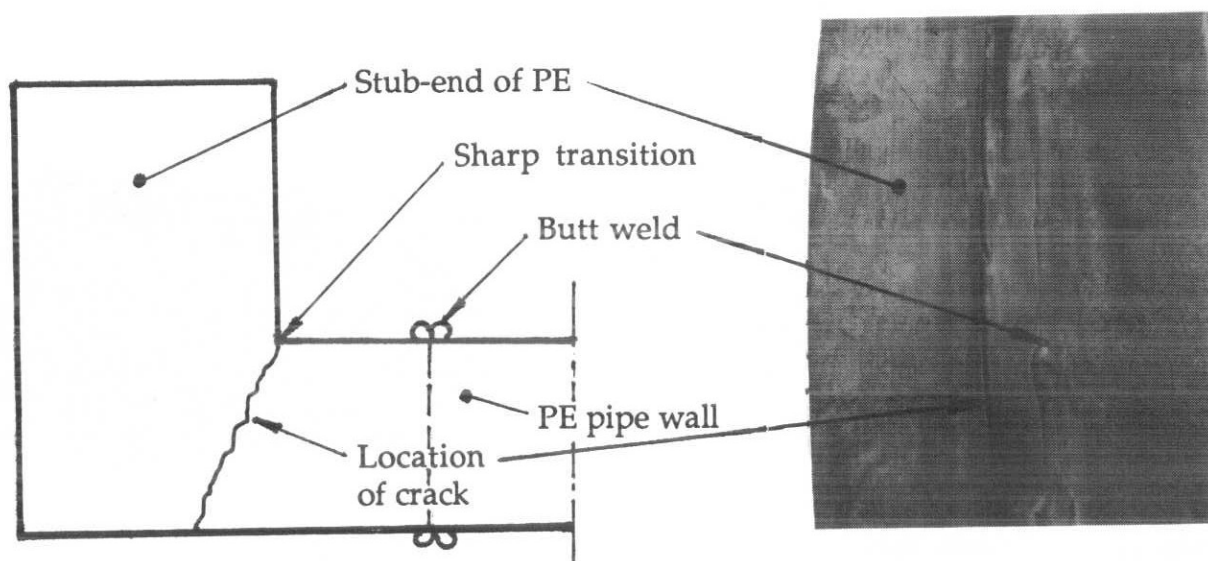
Figure 8: Crack in stub-end of PE

During the 5-year investigation period only 1 failure has been reported from a welded joint. The failure had not occurred in the weld itself but in a stub-end of PE welded on to the pipe. The transition from the pipe barrel to the flanged part of the stub-end was sharp, which probably caused stress concentrations in the stub-end which in turn led to the failure, see figure 8.

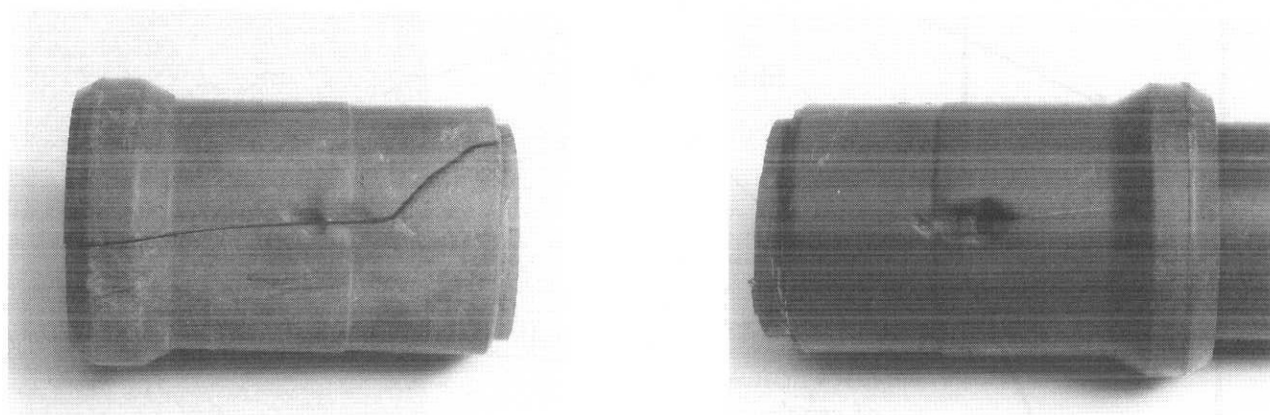
A considerable number of the failures which have occurred in PVC pipes manufactured before 1974 can be attributed to failures in injection-moulded sockets (168 of a total of 276 reported failures). However, even if this type of failure (fig. 2), which is well-known and can be attributed to bad material quality, is excluded, PVC pipes manufactured before 1974 still show a failure rate that is roughly 10 times higher than

Joint failures The predominant cause of failure in older PVC pipelines is still cracked injection-moulded sockets, see table V. The reason for this type of failure can be attributed to inferior long-term strength properties of the sockets. The problem was already attracting a lot of attention at the beginning of the 1970's, since it was already causing a considerable number of failures in PVC pipes, see table VI. Even if the failure rate has subsequently decreased, in 1990 it was still by far the most common cause of failure in PVC pipes.

Figure 2. Cracked injection-moulded sockets of PVC pipes (in the socket to the right, the leakage has abraided the socket at a small crack).

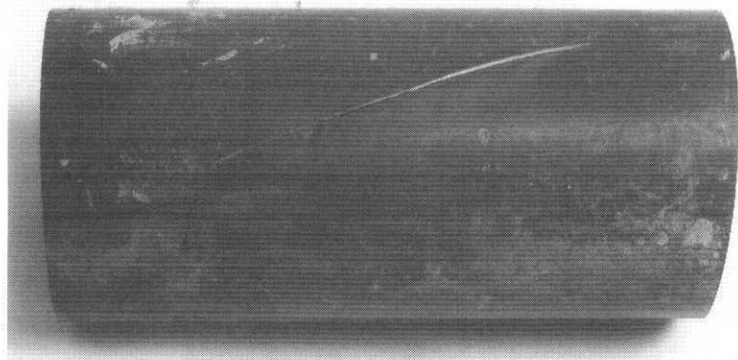
- 1) 45 of 76 failures have occurred on 14 pipelines with 2 or more failures on each line. The other 31 failures are single failures. In 12 cases, stones were found to be resting against the pipe. Settlements were noted in 3 cases. One failure was caused by freezing. Typical failures are shown in figure 3.
- 2) 3 failures were caused by external damage. 1 failure was located at the point where the line crossed a DN 1200 pipe where settlements had occurred. 1 failure had occurred where the pipe rested on rock.
- 3) In 2 cases, missing thrust blocks or anchorages at bends were reported.
- 4) The second failure on the DN 315 pipe occurred the day after the first repair at the same place (bad repair work).
- 5) Occurred on a pipe installed in 1974.

Figure 3. Examples of failed PVC pipes (to the left freezing in a PVC pipe; to the right a crack where the pipe has rested against a stone).

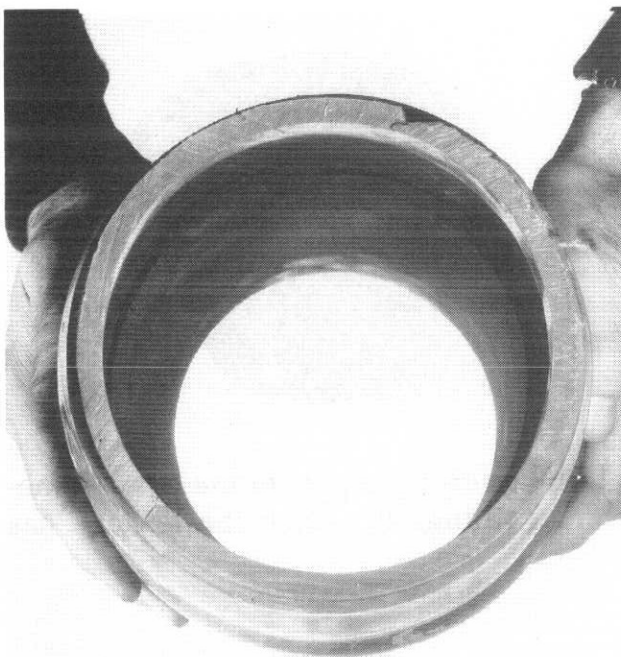
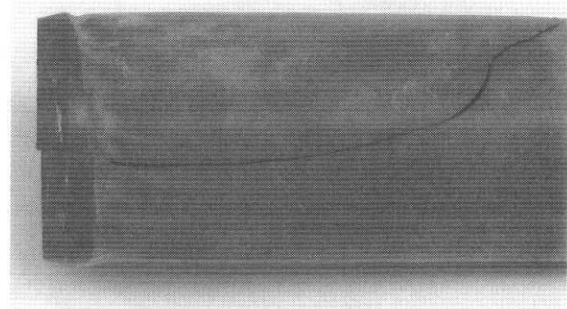
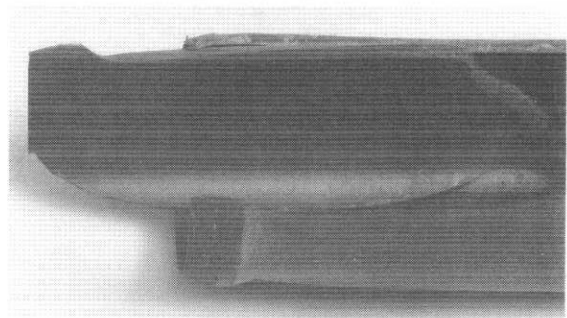
The second most common cause of failure is leakage in rubber ring joints (totally 16). For this type of failure, see figure 4, no major difference can be seen for pipes made before or after 1973. In almost all cases the leakage is either caused by displaced rubber sealings or bad anchorage of fittings. It is somewhat surprising that such failures do not reveal themselves to a greater extent. It seems that leakage in joints can generally be referred to bad workmanship during pipe installation.

Figure 4. Leakage in rubber ring joints on PVC pipes (to the left a displaced rubber sealing, to the right a spigot end which has not been correctly inserted in the socket and where the leakage abraded the spigot end until it finally failed).

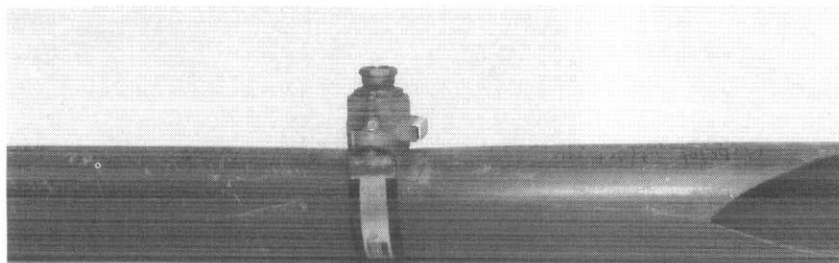
- 1) Two failures due to displaced rubber sealing. At least 6 failures caused by missing or bad anchorage of fittings.
- 2) Caused by a faulty saddle for house connection (a saddle intended for DCI pipes)
- 3) Two failures due to displaced rubber sealing. At least 4 failures caused by missing or bad anchorage of fittings (the latter failures have all occurred in a small municipality with a total of 29 km of PVC water pipes in the 399 km investigated).

For PVC pipes laid before 1974, certain other joint failures have also been found, see table V. For the additional failures, see figure 5, either a certain time is needed for the failure to occur (i.e. failures caused by corrosion or excessive stresses) or failures have occurred in fittings no longer used for PVC pipes (mechanical couplings), which is probably the reason why no such failures have been reported for pipes made after '73.

Figure 5. A failed PVC pipe at a saddle for house connection intended for DCI pipes.

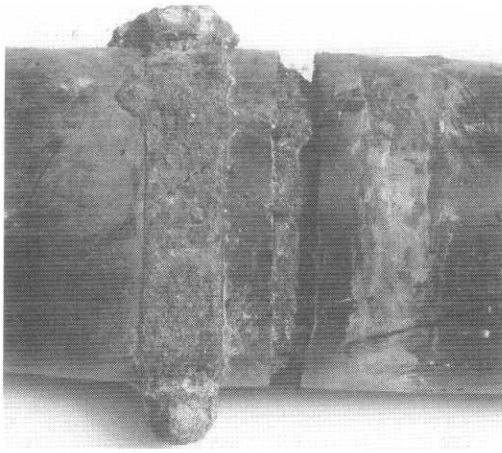
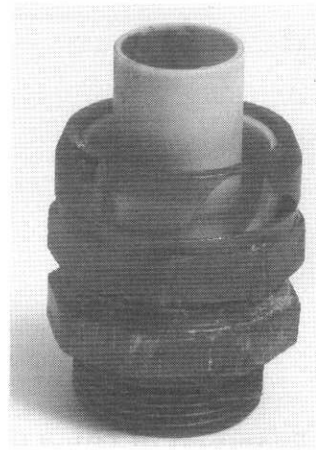
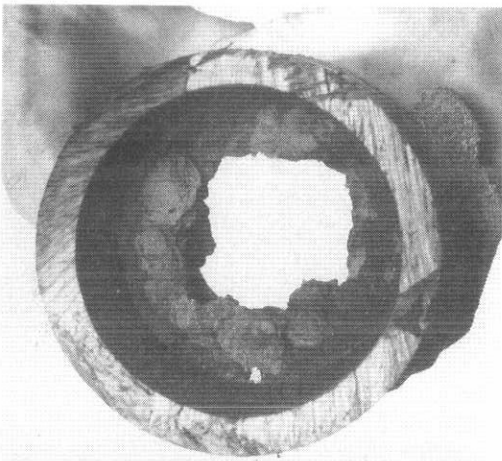
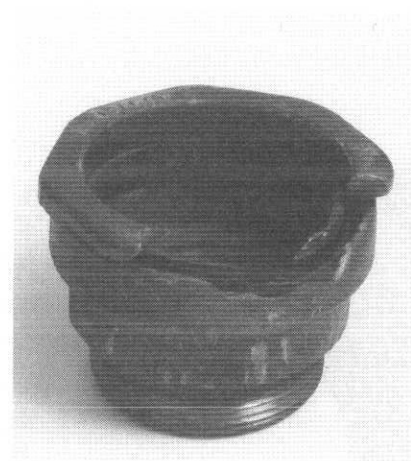
Of joint failures at mechanical joints, leakage is the most common failure (27 of 47 failures). There seems to be no specific correlation between this type of failure and the age of the pipe. Leakage at mechanical joints, see figure 6, has been found on old water pipes (after 27 years' operation) as well as on more recently installed pipes (after a couple of years' operation).

Figure 6. Examples of leakage in mechanical fittings on PE pipes (to the left a home-made fitting, heavily corroded, to the right brass fittings in which the leakage has caused abraision).

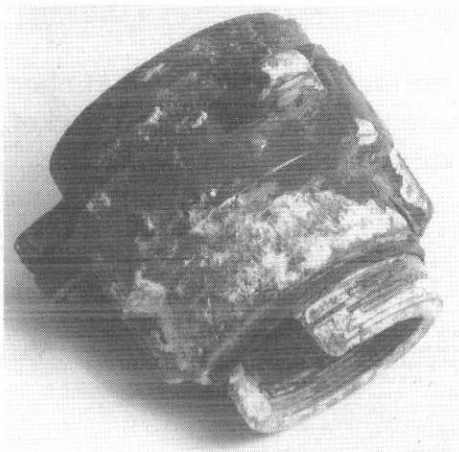
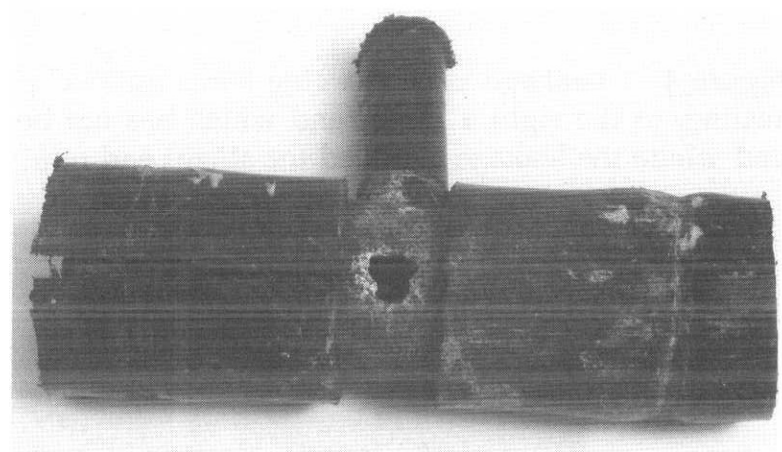
In the case of older PE pipes, corrosion of fittings, see figure 7, and broken pipes close to the fitting have also been reported (2 failures each).

Figure 7. Corrosion failures in fittings of PE pipes (to the left corrosion of a mechanical fitting of aluminium alloy, to the right corrosion in a steel fitting).
