Session: HDPE Pipe Test

Pilot Project with HDPE Provides Critical Alternative

Rafael Ortega, PE Lockwood, Andrews, & Newnam, Inc., Houston, Texas
Greg Henry, PE Lockwood, Andrews, & Newnam, Inc., Houston, Texas
Roel Huerta, EIT Lockwood, Andrews, & Newnam, Inc., Houston, Texas
Jonathan Prevot, EIT City of Houston, Texas

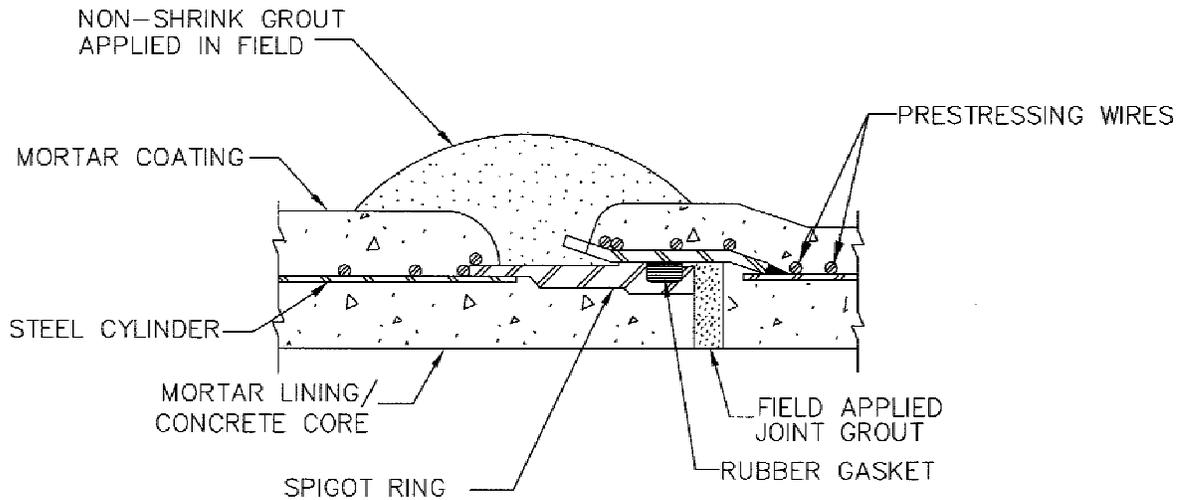
Figure 1. Lined Cylinder – Prestressed Concrete Cylinder Pipe

This particular PCCP is the lined cylinder variety, composed of a concrete core, prestressing wires wrapped around a thin steel cylinder, and mortar coating. Figure 1 shows a cross section of typical lined cylinder PCCP. A picture of the failed pipe section is included as Figure 2.

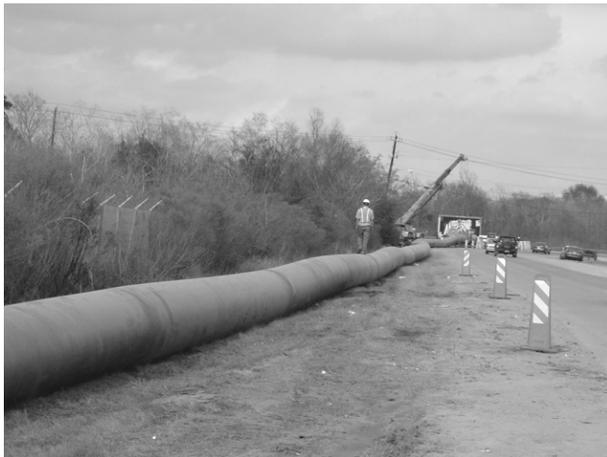
Figure 8. Pipe stringing and placement operations

The other major obstacles encountered during construction were traffic control, access to businesses when long runs of pipe were strung out along the right-of-way.
