# 10. Inspection, Maintenance and Repairs

Corrugated high-density polyethylene (HDPE) and polypropylene (PP) pipe, herein called corrugated plastic pipe (CPP), is durable and can have an exceptionally long service life. Age, physical damage, changing land use, subsequent adjacent excavation, and environmental exposure can lead to CPP maintenance. To ensure the long service life for the investment in any infrastructure, it is important to have an inspection and maintenance program. Routine in-service inspections can detect minor problems, allowing for early repairs that avoid serious problems in the future. This chapter will discuss performance characteristics, in-service inspection, maintenance, and minor repairs that maximize the useful life of CPP underground infrastructure.

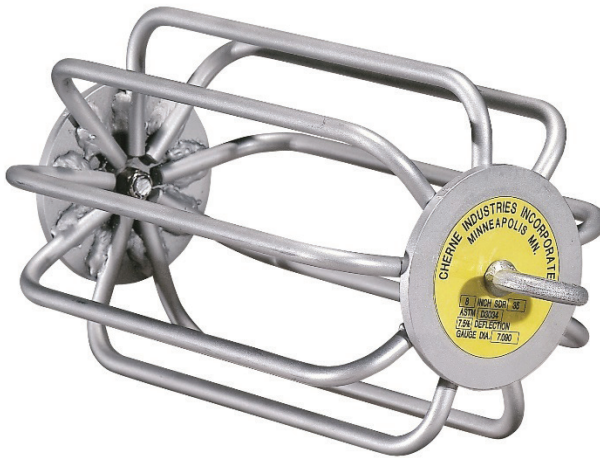
Mandrels are useful in identifying shape irregularities. Mandrels such as the one shown in Figure 10.1 are devices that are pulled through the pipe to determine whether the deflection observed is acceptable. They are pre-set with the minimum allowable inside diameter and if the mandrel can be pulled through the pipe, then the deflection is considered to be acceptable. An example of a mandrel in a pipe is shown in Figure 10.2.

Figure 10.1 – Typical Mandrel (Courtesy of Cherne Industries, Inc.)

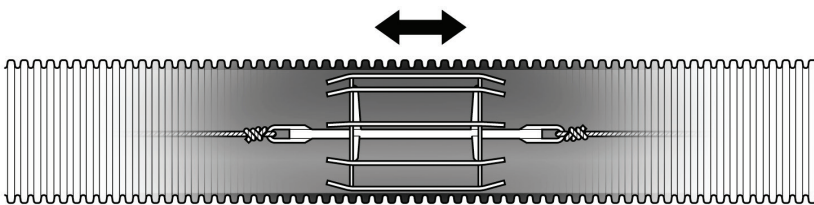
Figure 10.2 – Example Mandrel in Pipe

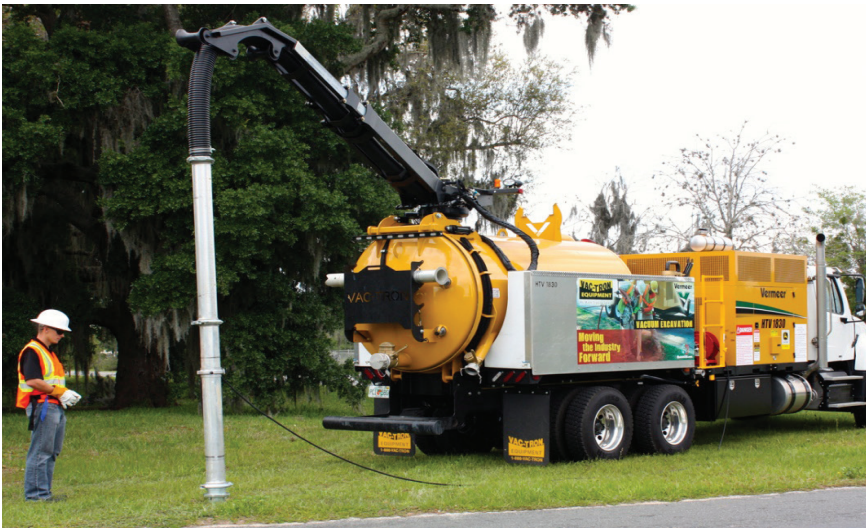
Vacuum pump equipment is typically mounted on a truck and is designed to remove blockages from storm drain and sanitary sewer systems, (as shown in Figure 10.3). These specialized trucks typically are outfitted with a holding tank reservoir capable of storing the material that was removed from the system. Catch basins, stormwater quality units, and underground retention/detention systems are often cleaned with this type of equipment. Materials removed as a result of these cleaning operations may have unique disposal requirements, and the owners are responsible for complying with all federal, state, and local regulations.

Figure 10.3: Typical Vacuum Pump Truck (courtesy of Vac-Tron Equipment, Inc.)

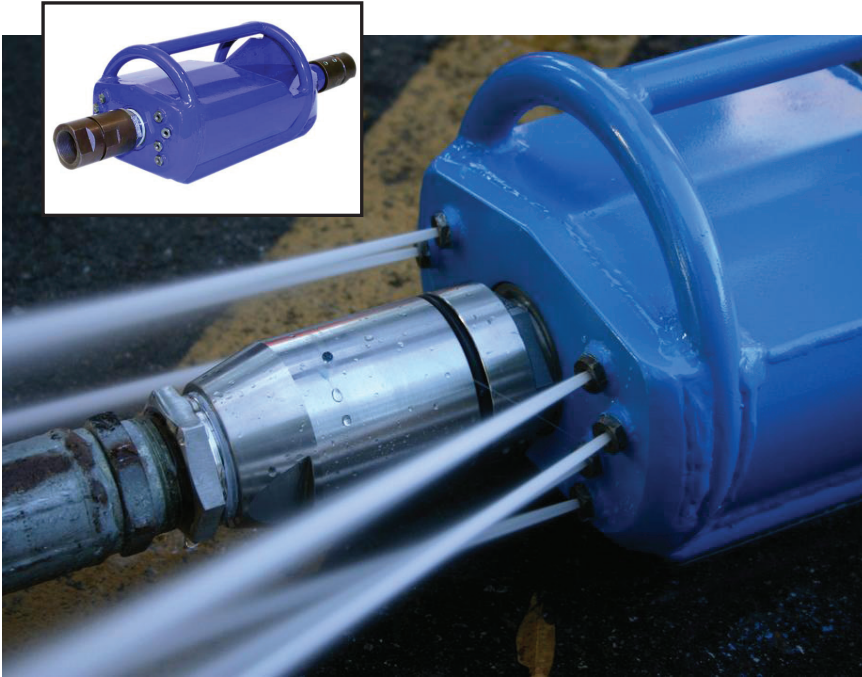
High-pressure sewer jetting is a method of cleaning drain and sewer pipelines using high pressure water. Water is delivered to a hose reel containing a high-pressure jetting hose with a nozzle on the end. The hose and pumps are typically mounted on a truck with its own water supply. The nozzle is designed

to direct high-pressure streams of water in an umbrella spray pattern to pull the high-pressure jetting hose through a pipe, (as seen in Figure 10.4). The angles of the water stream can be adjusted to produce better cleaning results. Some nozzles have a forward point jet that can penetrate a root mass or blockage.

Figure 10.4: Typical Water Jetting Nozzles

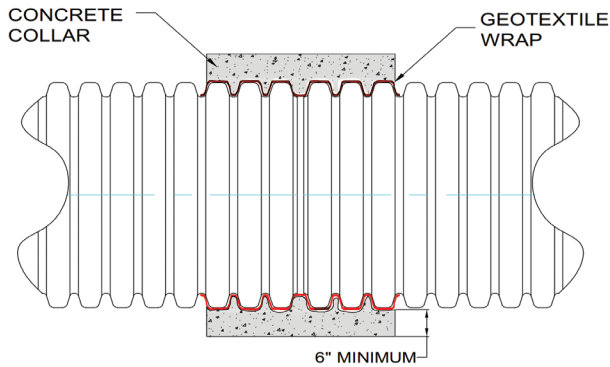
Concrete collars may provide an acceptable repair for soil-tight pipe, depending on the integrity of the installation. Installing a concrete collar involves building a form around the area to be repaired and encasing it in concrete as drawn in Figure 10.5. A geotextile is typically wrapped around the repair area prior to pouring the collar to keep the concrete from seeping into the pipe. Typically, an excavation of 6 in. (15 cm) beneath the pipe is done to allow for proper application of the geotextile and concrete encasement. If the pipe itself is damaged in an area that amounts to greater than 30% of the pipe diameter, then the damaged area shall be removed and a replacement pipe section will be spliced in prior to pouring the collar. In order to provide an improved level of joint performance, a gasket can be installed on the pipe in the concrete encasement.

**Figure 10.5: Typical Concrete Collar**

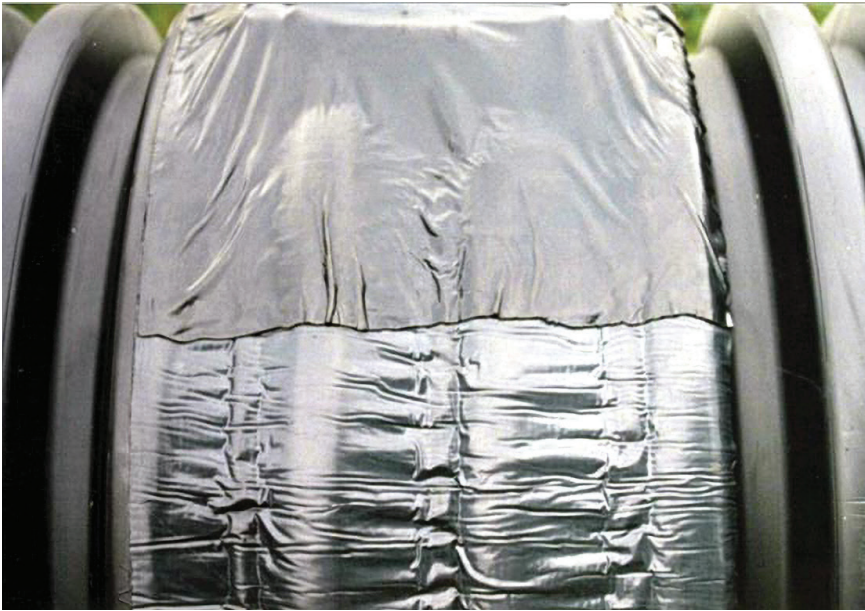
External mastic bands can be used to repair local small point distress or to seal joints. A MarMac Polyseal Pipe Coupler measures 4 to 60 in. (10 to 150 cm), and consists of a mastic adhesive base layer, and a cross-laminated polyethylene middle layer with a spun-bonded geotextile polypropylene cloth outer layer. The coupler incorporates a self-adhering rubberized bonding mastic and securing bands to ensure a positive seal around the pipe. If the pipe itself is damaged in an area that measures greater than 30% of the pipe diameter, the damaged area must be removed and a new pipe section spliced in before installing a coupler around both ends. Polyseal Pipe Couplers are typically used with soil-tight smooth interior CPP and one is presented in Figure 10.6.

**Figure 10.6: MarMac Polyseal Pipe Coupler**

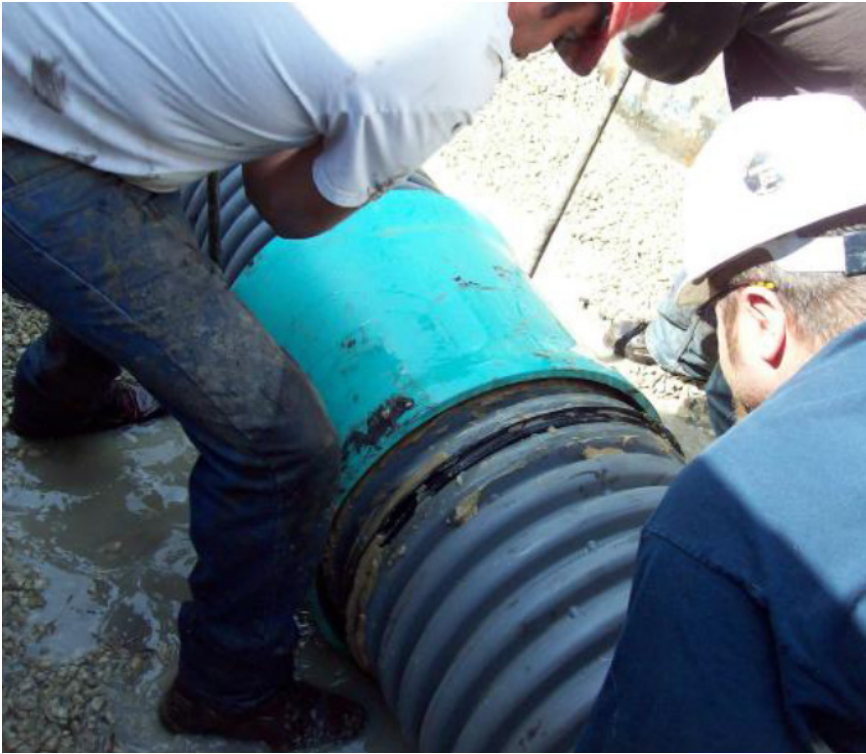
External slip repair couplings, for diameters between 4 and 30 in. (100 to 750 mm), are available from some CPP manufacturers, as shown in Figure 10.7. This device provides a watertight repair that will meet most pressure testing requirements, when installed correctly. The slip coupling uses PVC bells with gaskets. The gaskets are placed in the valleys on either side of the pipe section to be repaired and slip couplings are then slid over the gaskets. PVC slip couplings are most commonly used with watertight smooth interior CPP pipe products.

**Figure 10.7: Slip Repair Coupling**

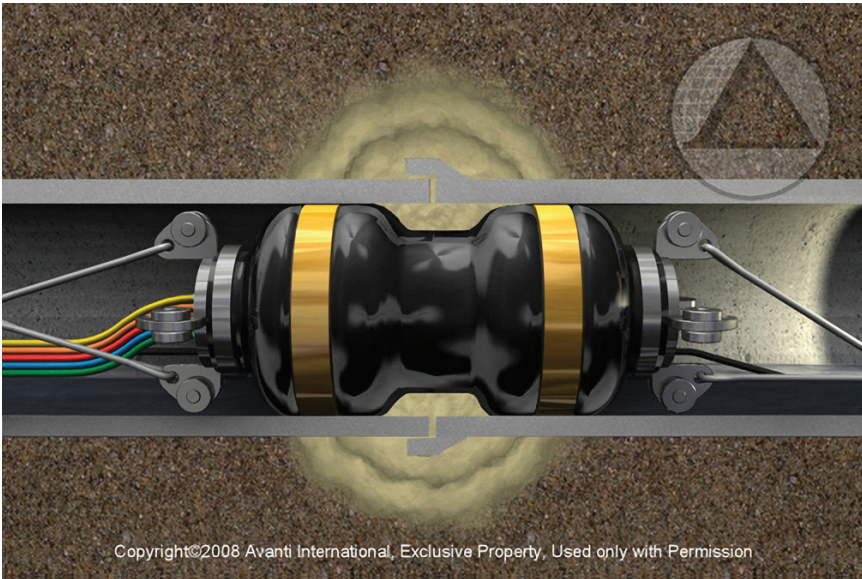
Chemical sealing is a method of joint repair using chemically-activated gel or grout to minimize the amount of joint leakage. The grout is typically applied with specialized remote-controlled equipment. The remote equipment packs the grout into the pipe joint and surrounding soil. Additionally, the remote equipment can be used to air test the quality of the pipe joint repair. Larger diameter pipes sized 36 to 60 in. (900 to 1500 mm) can be repaired by physically applying the chemical grout. In both methods of applying

chemical grout, the grouting material is forced through the joint out into the surrounding soil where it is set up as a gel as shown in the schematic in Figure 10.8. The gelled mass forms a waterproof collar around the pipe and results in a significantly reduced amount of leakage. There are several types of chemical grouts available and the manufacturer should be contacted to review the specific situation and any criteria related to joint tightness or the pressure test. The work should be performed in accordance with ASTM F2304 – *Standard Practice for Rehabilitation of Sewers Using Chemical Grouting* (5). Several companies manufacture and/or install chemical grout and most pipe diameters can be chemically-grouted as long as the grouting contractor has the appropriate equipment.

**Figure 10.8: Schematic of Chemical Grout Joint Seal (courtesy of Avanti International)**

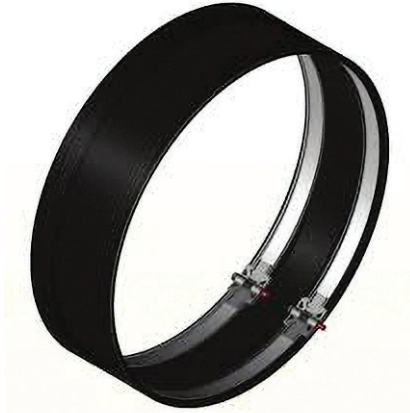
NPC Internal Joint Seals, are available in sizes 18 to 60 in. (450 to 1500 mm) diameters and consist of an ethylene propylene diene monomer (EPDM) rubber seal and stainless steel bands. The rubber seal is inserted into the pipe and positioned over the joint. A torque wrench is used to expand the bands against the inner wall of the pipe. This product is designed to seal the pipe joints, but not to repair damaged pipe sections. The damaged area of

the pipe must be removed and a replacement section must be spliced in, if necessary, to use an internal joint seal such as the one shown in Figure 10.9. This system may provide a watertight joint when installed as recommended. The manufacturer should be contacted to verify that the product meets the specific application requirements, including test requirements if specified. If pressure tests are required, the vendor should be contacted to ensure that the product is suitable for the specific test criteria.

**Figure 10.9: NPC Internal Joint Seal**
