TESTING COMPLETED FOR CORRUGATED HDPE PIPE IN SHALLOW COVER RAILROAD APPLICATIONS

*157-Ton Rail Cars Used in
Study of 48-Inch Diameter Corrugated Pipe;
Report Now Available*

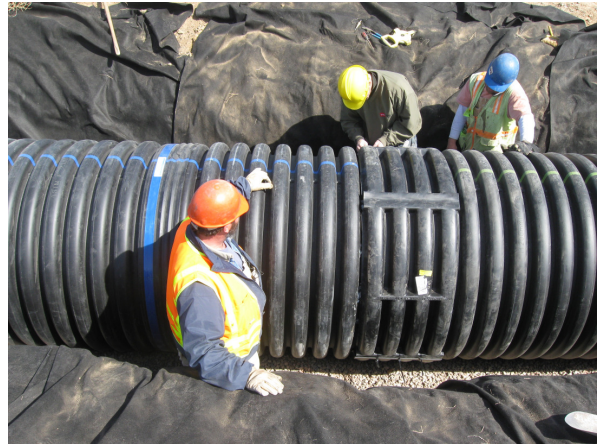
Pipe Installation

The pipes were installed in two adjacent locations in a fill on the High Tonnage Loop (HTL) at FAST.

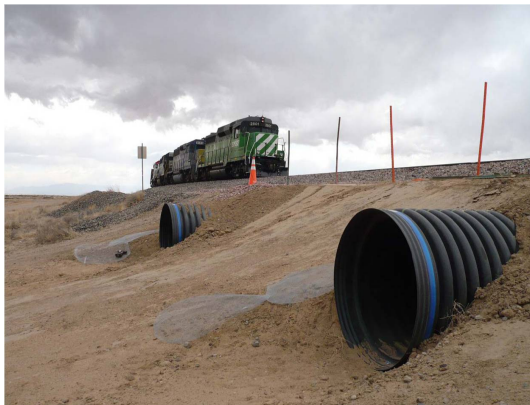
ADS constructed its standard watertight (WT) inline bell spigot joint, and its standard fabric wrapped split coupler connection for each pipe. The connections in each pipe were placed just outside the centerline of the rails. Pipe installation followed standards outlined in ASTM D2321 and in the study.
