RESERVOIR RISK MANAGEMENT SYSTEM BUILT USING CORRUGATED HDPE PIPE

Relieves Upward Pressure on
Underwater Liner

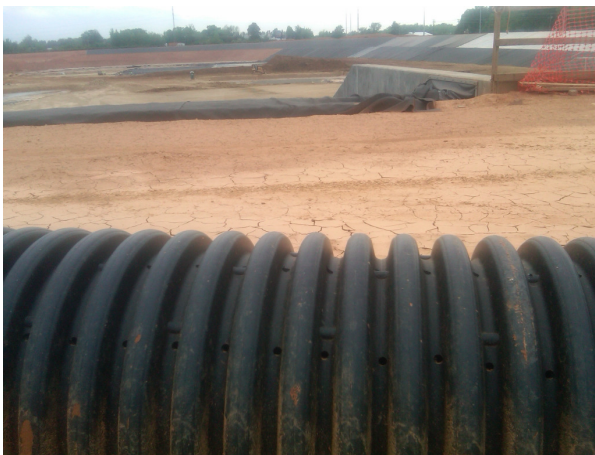
Corrugated HDPE pipe with a Class II perforation pattern enables water to enter the long-life system and be conveyed to a central collection point.

The Class II perforation pattern enables water to enter the corrugated HDPE pipe from any direction and be conveyed to a central collection point and then into twin lines of solid wall HDPE pipe that run under the dam and to a manhole.

The corrugated HDPE pipe sits in cut and covered trenches and is enveloped in a geotextile fabric that enables water to enter the perforated pipe while keeping sand and other fine particles out of the system. Some 3,500 feet of six-inch and 5,400 feet of eight-inch diameter corrugated HDPE pipe meeting AASHTO M-252 and 1,780 feet of 12-inch and 3,900 feet of 18-inch diameter corrugated HDPE pipe meeting AASHTO M-294 was used.

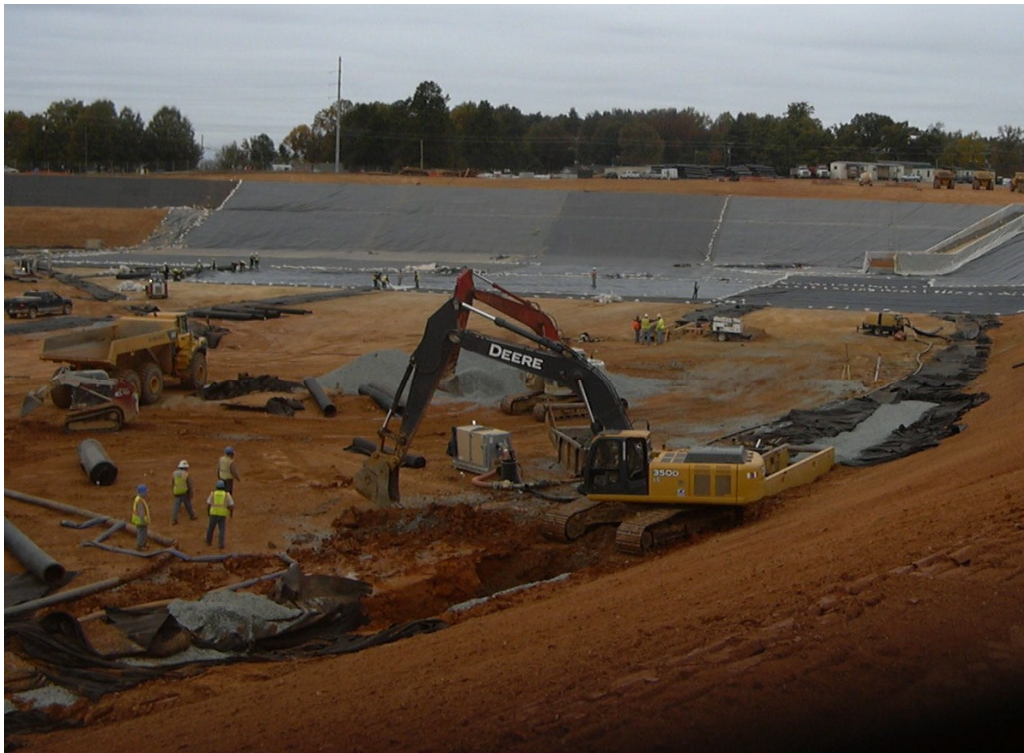
The Franklin Water Treatment Plant Reservoir Expansion project used corrugated HDPE pipe to create an underdrain system that will protect the geotextile liner. The 27-acre site was excavated to a depth of 30 feet. More than 14,600 feet of pipe was used for the project which was recently named Project of the Year by the Plastics Pipe Institute.
