## RESERVOIR RISK MANAGEMENT SYSTEM BUILT USING CORRUGATED HDPE PIPE

Relieves Upward Pressure on  
Underwater Liner

CHARLOTTE, N.C. - For a new 250-million gallon capacity water reservoir here, dual wall, corrugated high-density polyethylene (HDPE) pipe is being used as a safety system to protect the liner that covers the entire reservoir bed. The six-, eight-, 12-, and 18-inch diameter perforated pipe collects water seepage to reduce the pressure underneath the liner and prevent it from floating. More than 14,640 linear feet of pipe was used for the system that sits under 35 feet of water and four feet of fill.

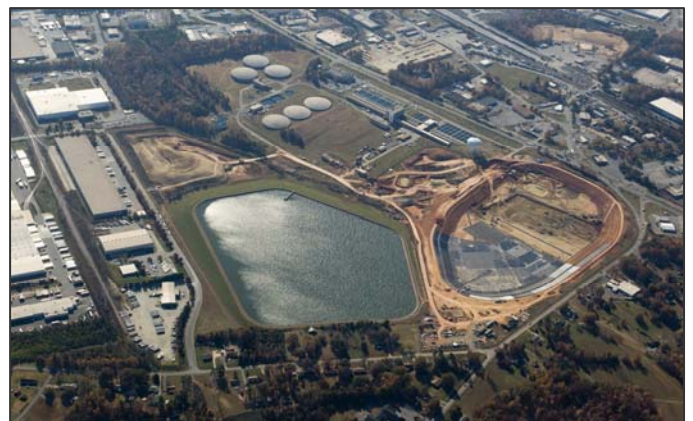
Photo by Steve Montgomery, Skyshots.net 800/656-8888

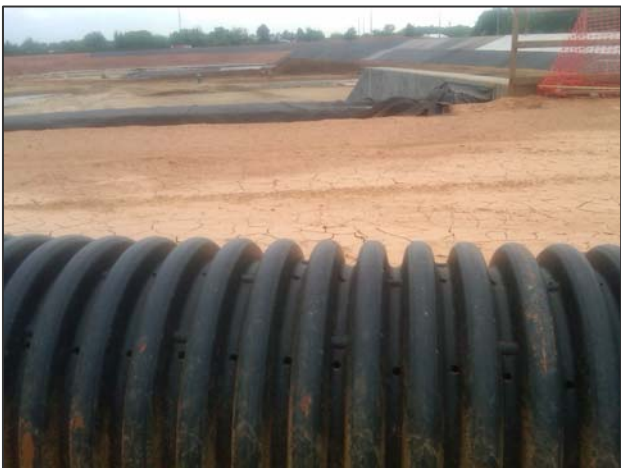
Corrugated HDPE pipe with a Class II perforation pattern enables water to enter the long-life system and be conveyed to a central collection point.

The Class II perforation pattern enables water to enter the corrugated HDPE pipe from any direction and be conveyed to a central collection point and then into twin lines of solid wall HDPE pipe that run under the dam and to a manhole.

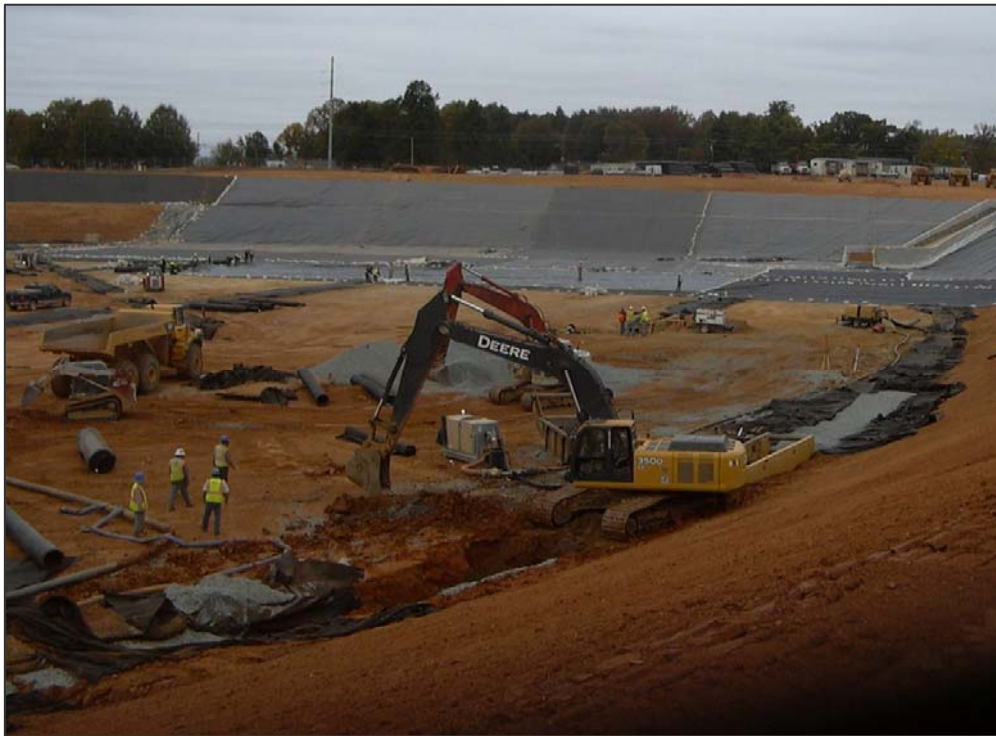
The Franklin Water Treatment Plant Reservoir Expansion project used corrugated HDPE pipe to create an underdrain system that will protect the geotextile liner. The 27-acre site was excavated to a depth of 30 feet. More than 14,600 feet of pipe was used for the project which was recently named Project of the Year by the Plastics Pipe Institute.
