Pipes Successfully Relined

During routine testing, the Los Angeles Department of Water and Power's (LADWP) Trunk Line Testing Program identified leaks in two trunk lines. The identification of weak points in LADWP's large-diameter pipelines is designed to reduce emergency repairs, collateral damage, and prolonged service interruptions.

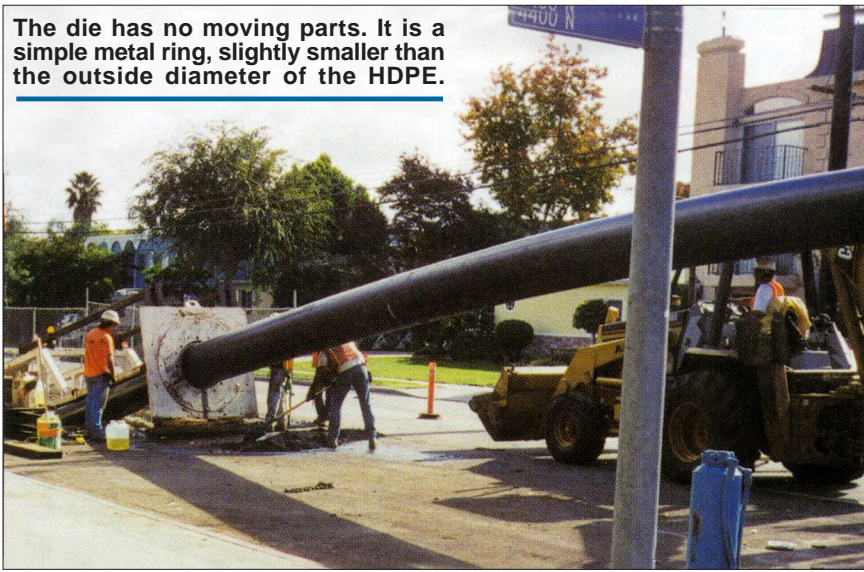
The PE liner is pulled through a die which temporarily reduces its diameter and allows it to pass through the host pipe without damaging either the pipe or the liner.

The die has no moving parts. It is a simple metal ring, slightly smaller than the outside diameter of the HDPE.

Just before the fused pipe entered the host pipe, it passed through a simple metal ring, or die, which temporarily reduced the outside diameter of the PE pipe. The reduced diameter was slightly less than the inside diameter of the host pipe, so the PE pipe could be pulled into place without exceeding 50% of the yield strength of the material. As long

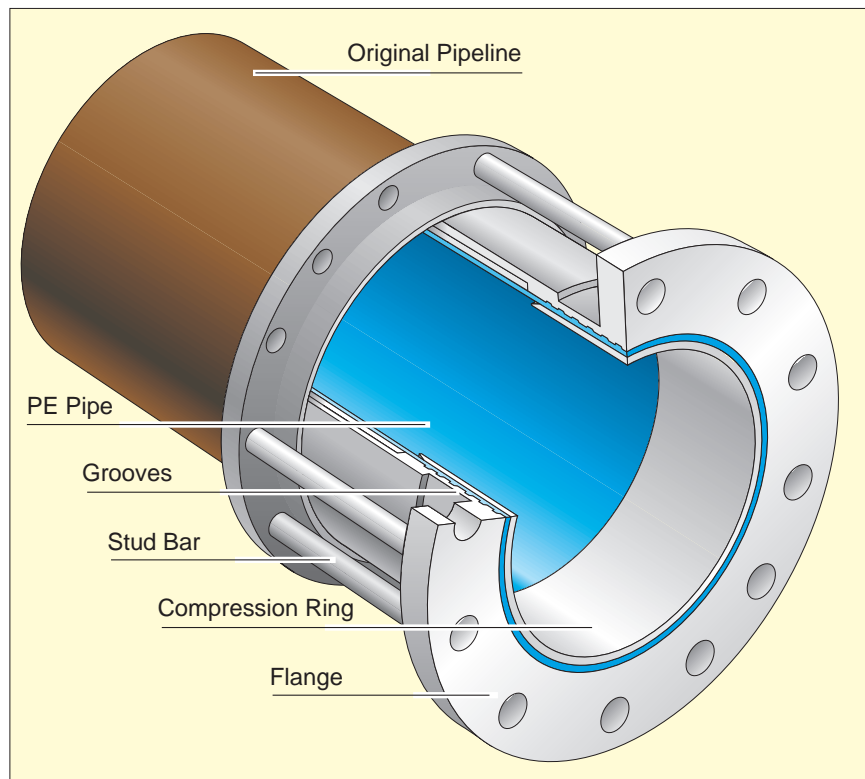
as the yield-strength of the PE is not exceeded, no permanent deformation will occur.
